# Safety Alert: Chainsaw Kickback

Date: 17/01/2024	Focus Group: All Forestry Contractors
Topic: Chainsaw kickback	Issued by: Travis Terry

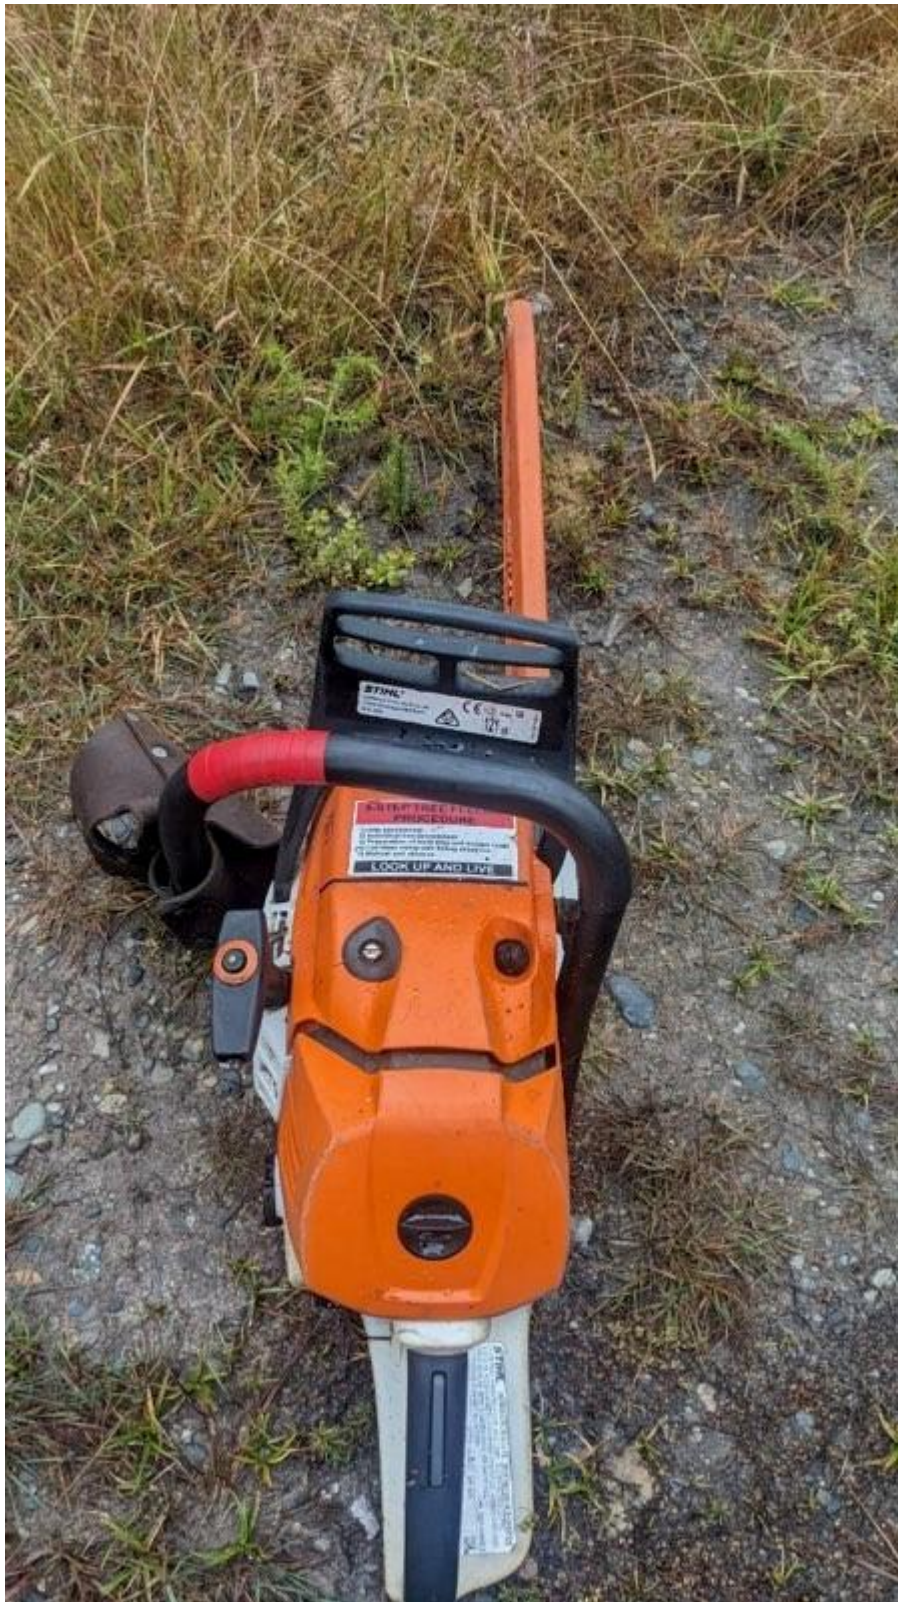
- Safety Behaviour:**
- When using a chainsaw be prepared for the possibility of kickback.
  - The contractor has implemented a coloured band on the roll over handle (see photo) to serve as a visual reminder to operators of the position of their hand and the heightened risk of the chain brake not activating if required while their hand is in this position.

While there were recommendations relating to changes in the technique applied in this particular situation to prevent this reoccurring. The investigation identified that, when the chainsaw was held in a particular position along the wrap around handle, the safety chain brake may not activate as expected in the event of kickback.
