Safety Alert

Crew Ute and Log truck Collision

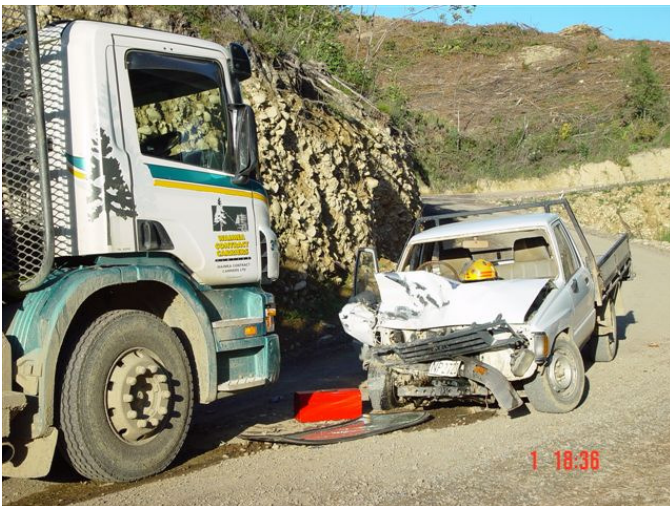
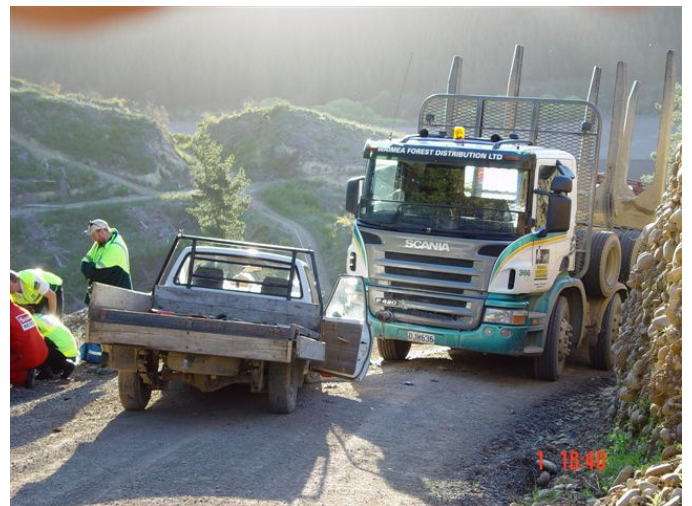
Operator was leaving skid at end of day by himself in a crew Ute. He had completed load outs for night shift and stayed later than expected. The crew Ute did not have a radio and the handheld normally used was missing. The driver did not hear the log truck call that he was entering the road system and on his way in. driver came around the corner and was too far inside and collided with the log truck. GOOD NEWS – Both drivers were wearing their seatbelts which avoided serious injury.

- Always keep left and drive at a speed you can stop in half the visible distance.
- All crew vehicles should be fitted with a RT or have a handheld where RT is needed for temporary use.
- Never drive to your radio always expect a vehicle around the corner.
