HAZARD ALERT

August 2009 - Two rock trucks collide on forest road

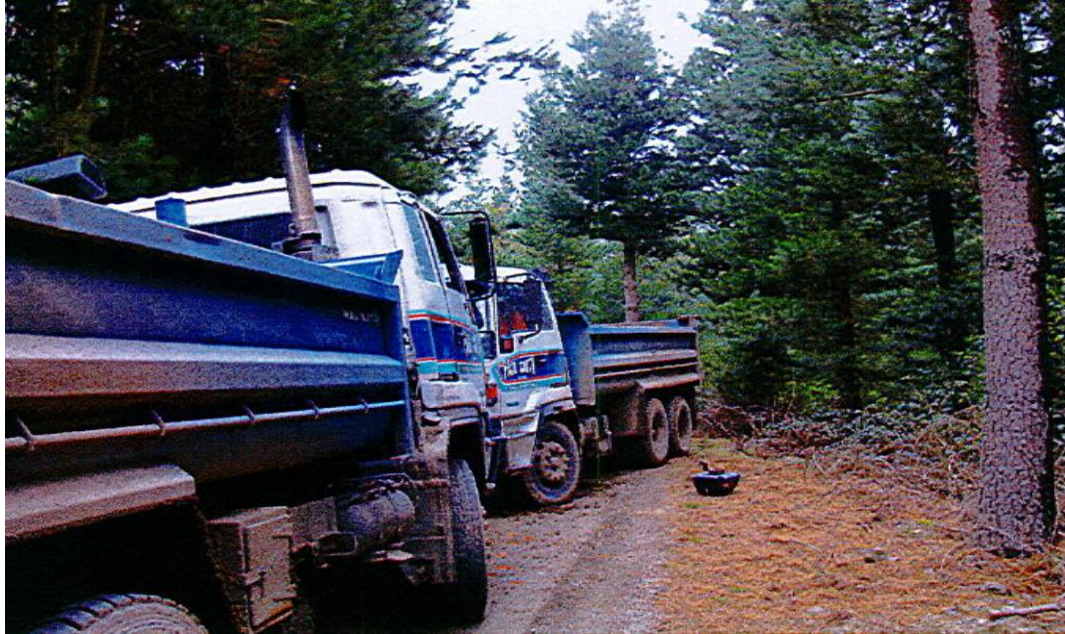
Two rock trucks were working in Geraldine Forest. Initially these trucks had been travelling in convoy, but due to a number of factors they became separated. The drivers were keeping in contact via the RT, but there was a misunderstanding in the communications and they both drove towards each other expecting the other truck to be waiting. The trucks met on a corner with poor visibility – one of the trucks managed to stop but the other slid under braking and they collided head-on. There were no major injuries, but significant damage to both trucks.

- **Always drive to the conditions – you MUST be able to stop in half the clear distance ahead of you. Drive with the expectation that a vehicle may be coming the other way at any time.**
- **RT calling procedures are useful for communicating with other vehicles and planning passing locations, but NEVER rely on the RT to assume the road ahead is clear. A message may have been misunderstood, not heard, or there may be vehicles on the road without RT's.**
- **When planned work procedures change, all people must be aware of what is happening and adjust their actions accordingly.**
